National Register of Historic Places
Continuation Sheet

Bates, John M. and Elizabeth, House
No. 4

Clackamas Co., OR

This is a Petition to delist the Bates House, No. 4 located at 4101 SW Southshore Drive, Lake Oswego, Oregon from the National Register of Historic Places. The residence is a single-story house on a daylight basement. It was designed in the 1950s and completed in 1954. The residence was listed on the register due to its architecture and engineering, including, closets, cabinetry, moldings and brass fittings. However, since that listing in 1990, those qualities (and details) have long ceased to exist.

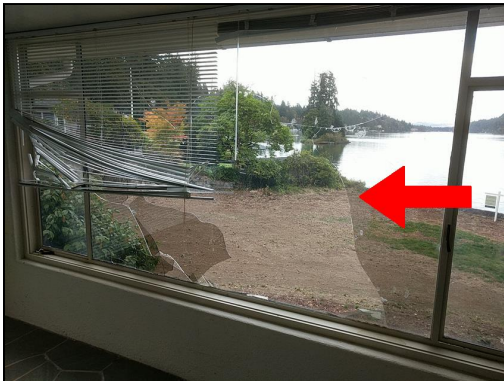
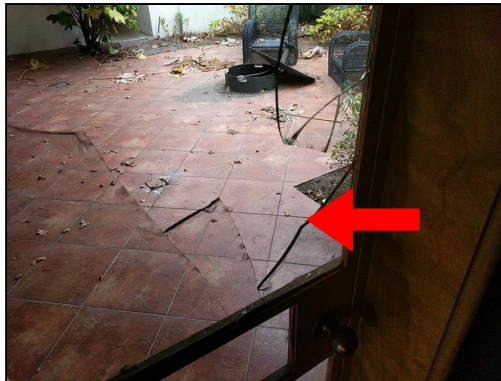
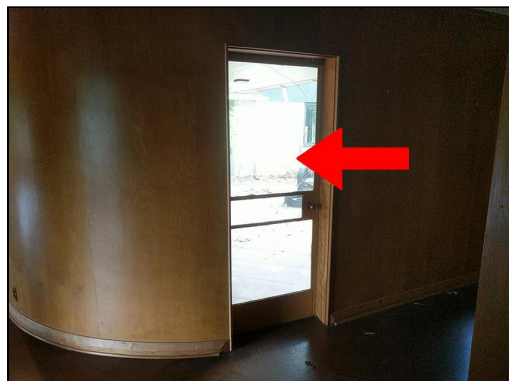
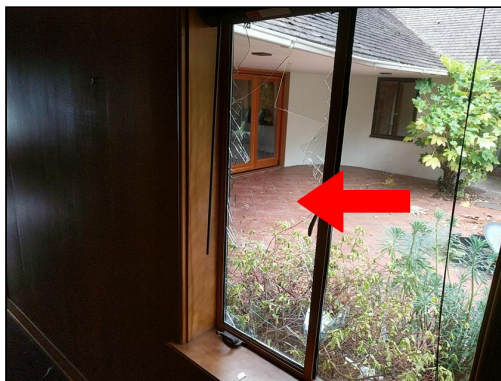
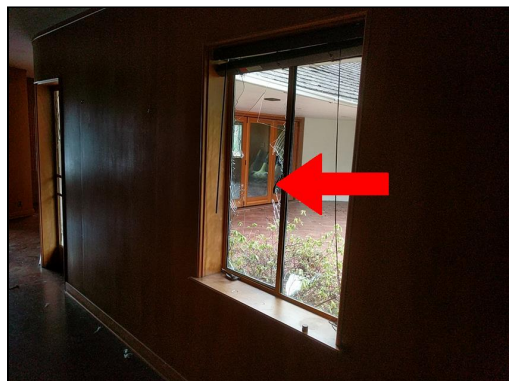
5.3.A The glazing (glass) at multiple windows in the hallway and sunroom was cracked or broken and needed replacement. Recommend repairs by a qualified contractor.

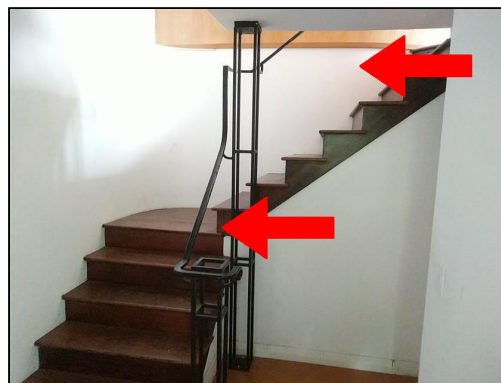
5.6.A The handrail assembly at the staircase had excessive spaces between the balusters which is a safety hazard. Balusters at a stairwell railing should be spaced close enough together that a 5-inch sphere cannot pass between balusters. Recommend correction to the baluster spacing by a qualified contractor to improve child safety and to bring the stairway railing up to modern safety standards.

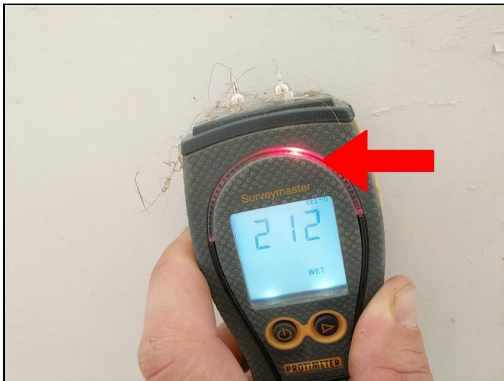
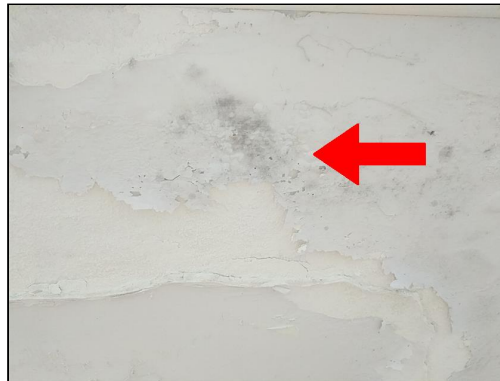
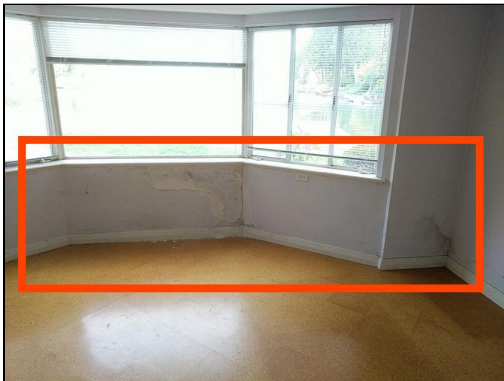
5.0.B Elevated moisture was detected and what appeared to be microbial growth was visible on the walls in the downstairs bedroom. The type of growth or number of spores was not determined and would require specialized testing and laboratory analysis. The underlying cause is moisture. Recommend further analysis by a qualified mold remediation specialist and identifying and correcting the source of moisture intrusion by a qualified contractor.

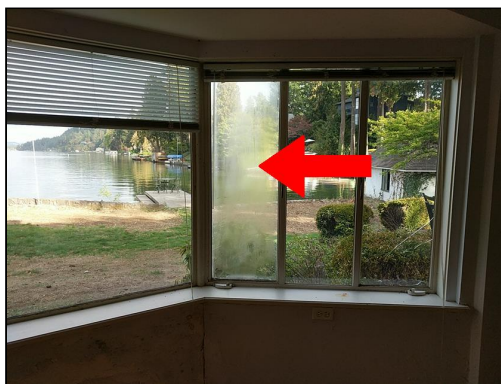
5.3.B (1) Condensation and / or stains visible in the glass of a double-pane window in the downstairs bedroom indicated a loss of thermal integrity and failure of the window seal. Recommend consulting with a qualified contractor to discuss options and costs for replacement.

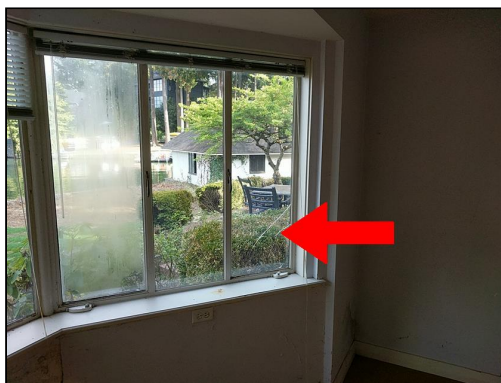
5.3.B (2) The glazing (glass) at a window in the downstairs bedroom was cracked or broken and needed replacement. Recommend repairs by a qualified contractor.

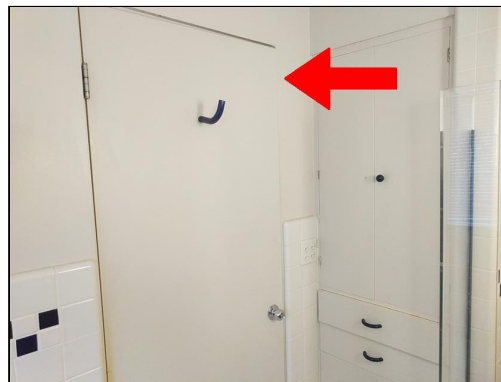
6.2 The door at the master bathroom was binding at the door jamb and did not properly open/ close and needed adjustment. Recommend correction by a qualified contractor.

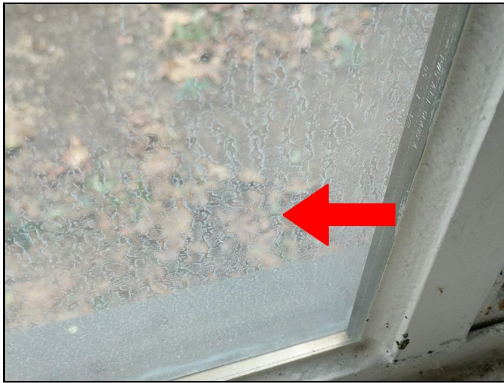
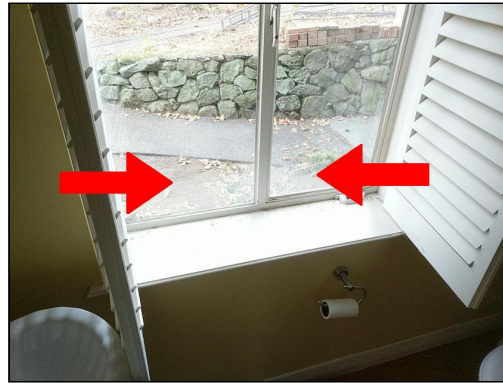
6.3 Condensation and / or stains visible in the glass of a double-pane window in the downstairs hallway bathroom indicated a loss of thermal integrity and failure of the window seal. Recommend consulting with a qualified contractor to discuss options and costs for replacement.

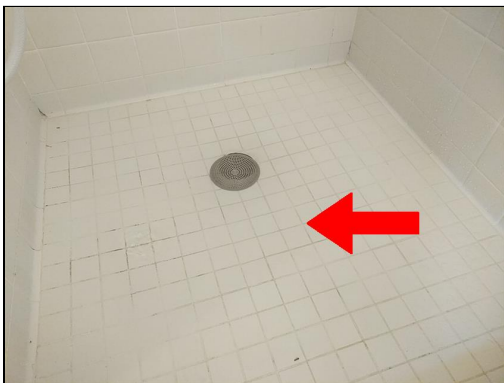
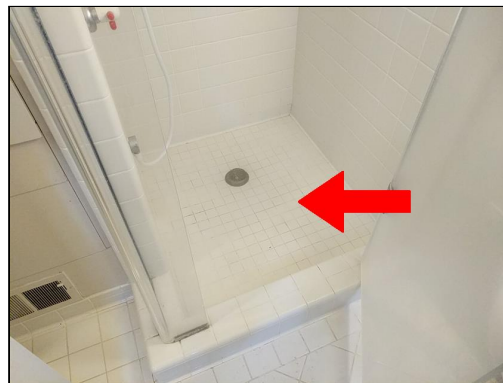
6.7 The shower in the master bathroom was slow to drain. Other fixtures in this bathroom drained normally, indicating a localized plumbing blockage. Recommend having this drain line further evaluated and / or cleaned by a qualified plumbing contractor.

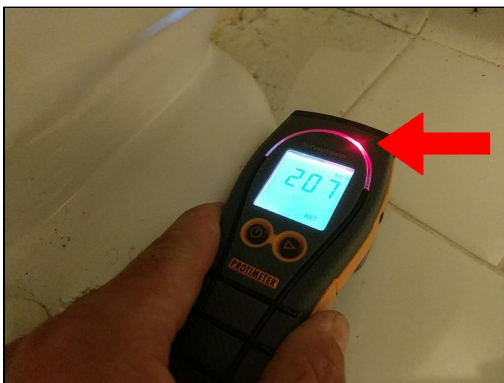
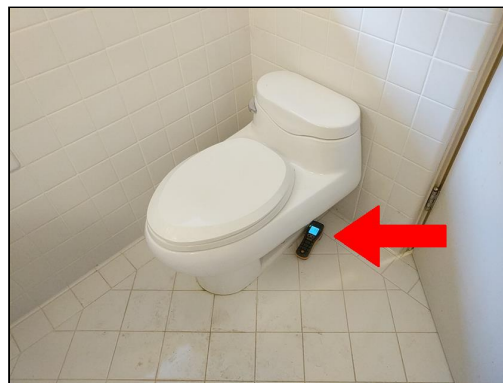
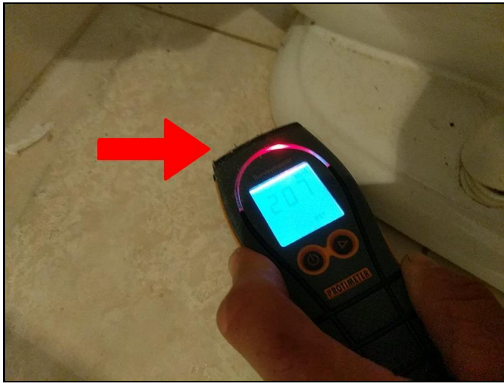
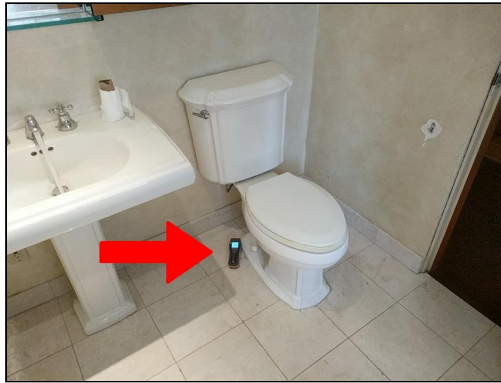
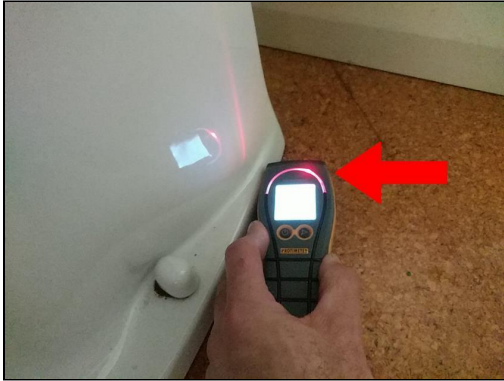
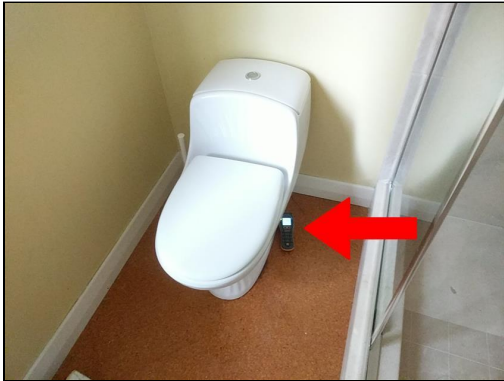
6.8 Moisture meter readings at the base of the toilet in the master bathroom, hallway bathroom, and downstairs bathroom indicated elevated moisture levels were present in the sub-floor around the toilet. This is typically due to failure of the wax ring that seals the toilet to the floor. Recommend replacement of the wax ring by a qualified plumbing contractor.

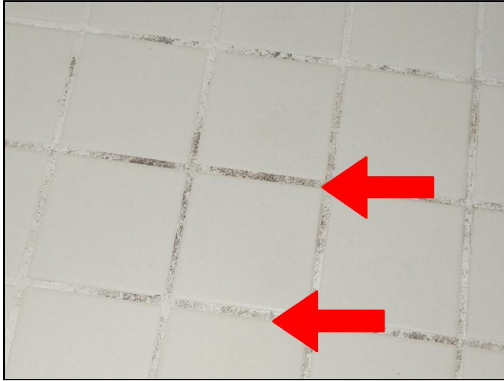
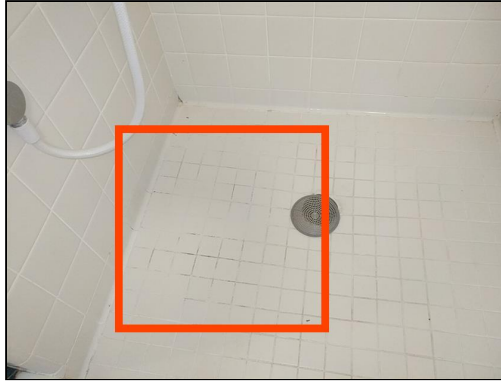
6.9 (1) Grout at the master bathroom shower was deteriorated from microbial growth and needs replacement or repairs. Recommend further evaluation and repairs as needed by a qualified contractor.

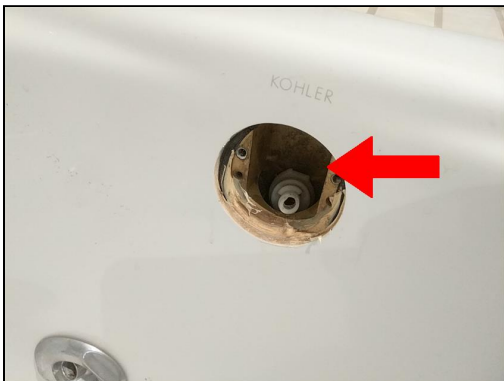
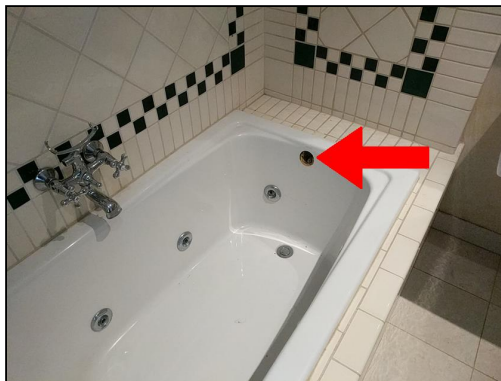
6.9 (3) The bathtub in the upstairs hallway bathroom was missing the drainage controller. Recommend repairs by a qualified plumbing contractor.

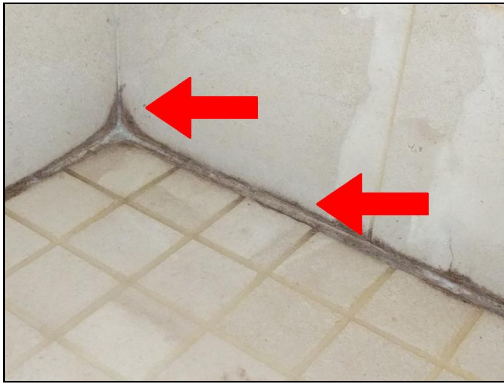
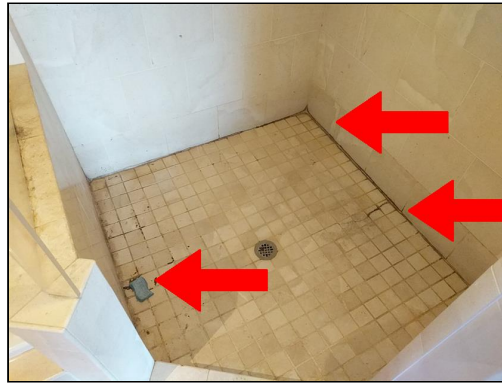
6.9 (4) The downstairs bedroom shower was severely deteriorated and had extensive microbial growth around the walls and floor. Recommend further evaluation and repairs as needed by a qualified contractor.

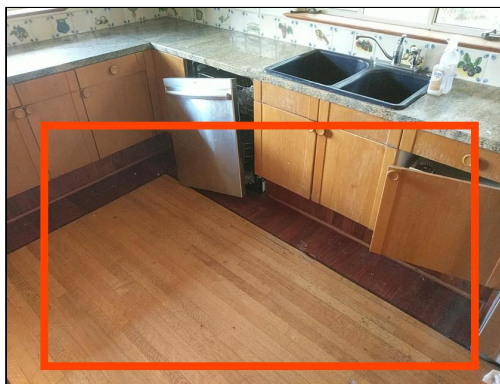
7.1 Kitchen floors had extensive water damage and will need replacement. Recommend consulting with a qualified flooring contractor for options and costs for repairs or replacement.

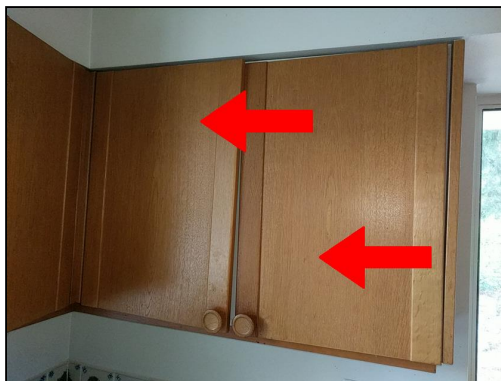
7.6 Multiple cabinet drawers and doors were binding and inoperable. Recommend further evaluation and repairs as needed by a qualified contractor.

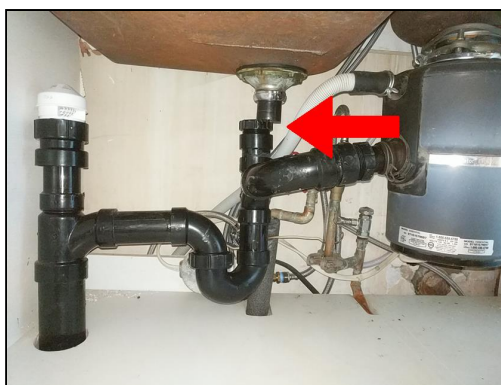
7.7 (1) The p-trap assembly at the kitchen sink waste line was broken and leaking. Recommend further evaluation and repairs by a qualified plumbing contractor.

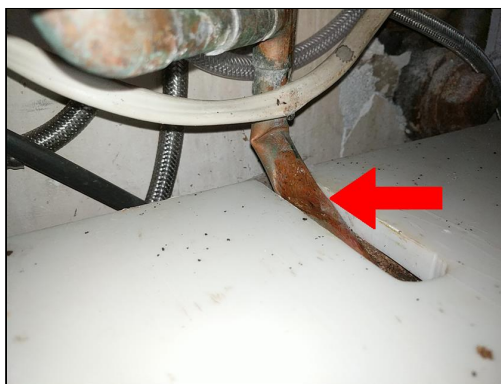
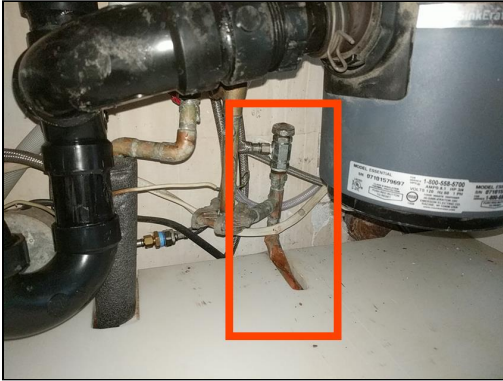
7.7 (2) The cold water shutoff valve was leaking below the kitchen sink. Recommend repairs by a qualified plumbing contractor.

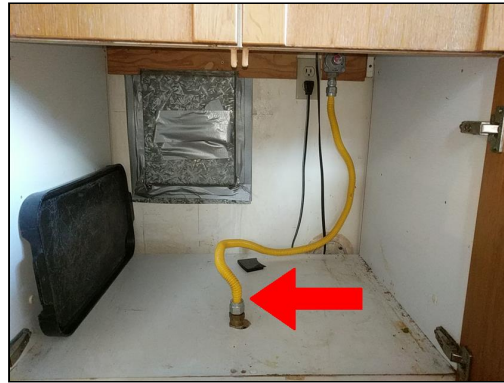
7.8 No gas shutoff was installed at the cooktop as required. Recommend correction by a qualified plumbing contractor.

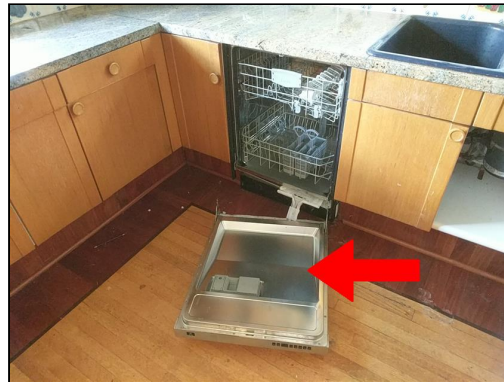
7.10 Dishwasher was broken and will need replacement.

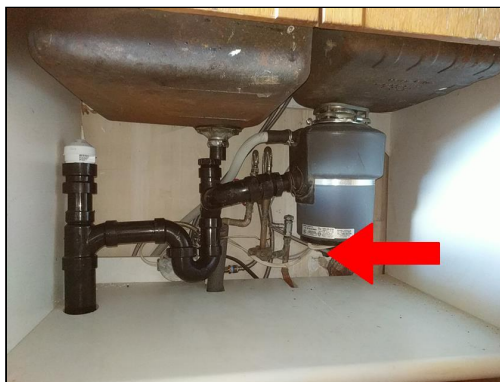
7.11 The electrical connection to the garbage disposal was improper at the time of the inspection. The disposal should either be powered by an approved appliance cord plugged into a dedicated outlet, or be hard-wired directly to a dedicated 20-amp circuit. Romex cable is not an approved type of appliance cord and should not be exposed outside of a wall cavity. Properly spliced connections should be housed within an appropriate junction box with a listed cover installed. The current configuration is a fire / shock / electrocution hazard. Recommend correction by a qualified electrical contractor.

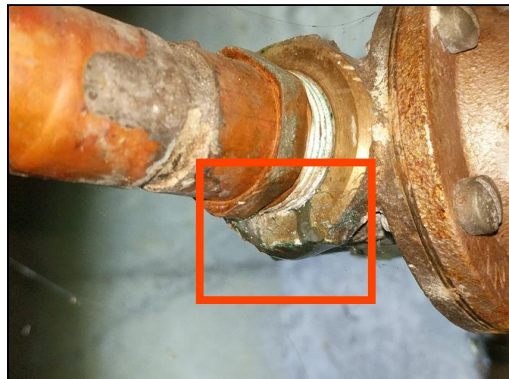
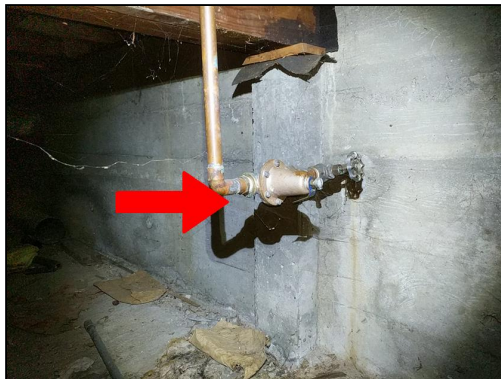
9.2 The plumbing water supply line was leaking next to the pressure regulator. Recommend further evaluation and repairs as needed by a qualified plumber.

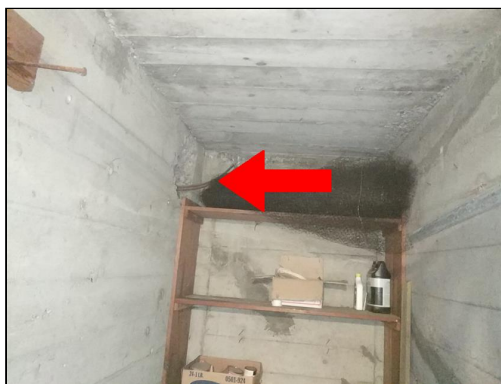
9.5 Evidence of the presence of an underground oil storage tank was visible at this home. Indications that an underground tank could be present may include vent pipes, refill pipes, an oil filter, and / or supply pipes. The tank was not inspected and the inspector disclaims the condition of the tank. Recommend asking the seller to provide any documentation about the decommissioning of the tank and whether it has been removed or not, or further evaluation by a tank scanning technician. More information about oil tank decommissioning and responsibilities can be found at the following [link](#).

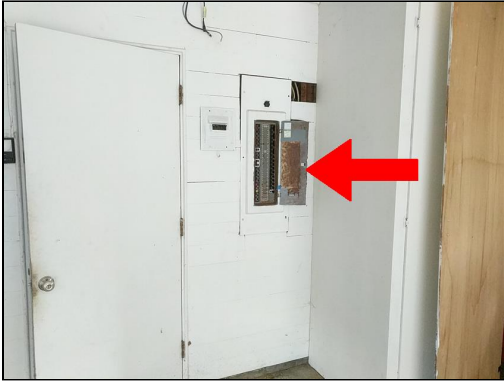
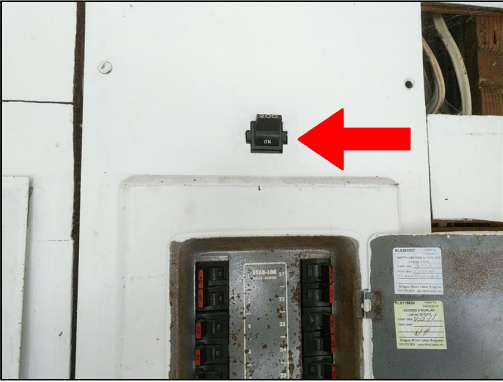
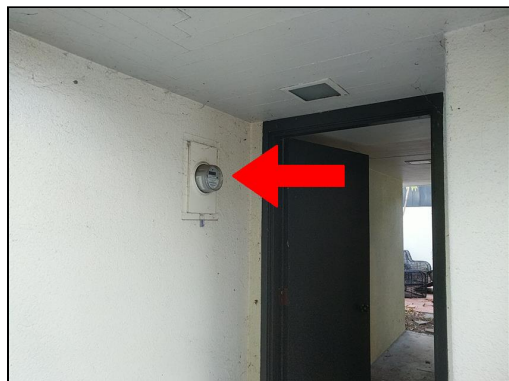
10.0

The main distribution panel was located in the garage.

The main service disconnect is located at the main distribution panel. The breaker switch indicated in the photo is the main service disconnect. In the event that the power needs to be turned off to the entire house at once, this breaker should be flipped which should cut power to the entire home and all sub-panels being fed from the main panel. Always double check that the power is not live before ever touching electrical wires as they are a shock and electrocution hazard if touched when live.

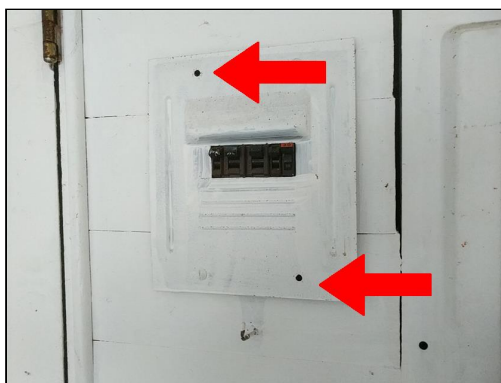
10.2 (1) The main distribution panel cover was missing one or more panel cover screws. Panel covers should be securely attached with all screws in place. Recommend replacement of the missing screw(s) with proper panel cover screws by a qualified electrician.

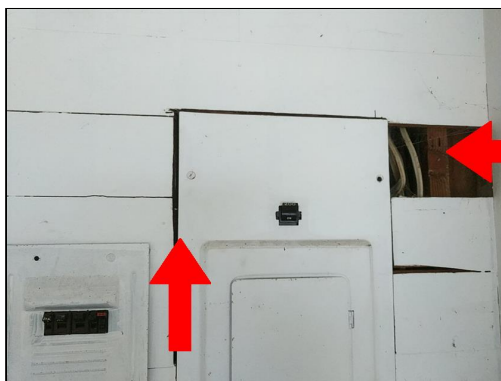
10.2 (2) Gaps around the edge of the panel cover were visible which leave energized electrical components exposed to touch and is a fire and safety hazard. No gaps larger than 1/8 of an inch should be visible around the panel cover. Recommend correction by a qualified electrician.

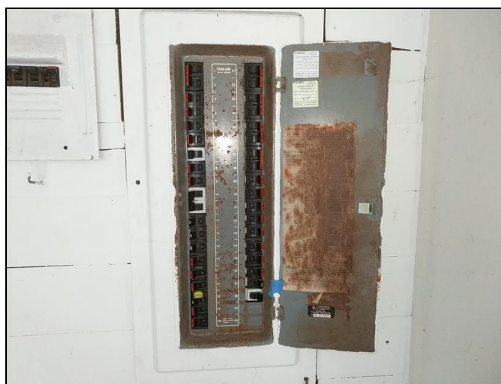
10.2 (3) The main distribution panel is a Federal Pacific / Stab Lok panel. These panels are generally considered unsafe as they have a reputation and pattern of not tripping the circuit breakers when they are overheated or when they experience a short, which is a fire / shock / electrocution hazard. It is

highly recommended that all Federal Pacific panels be replaced. Recommend consulting with a licensed electrical contractor for further evaluation and to discuss options and costs for upgrading the electrical panel.

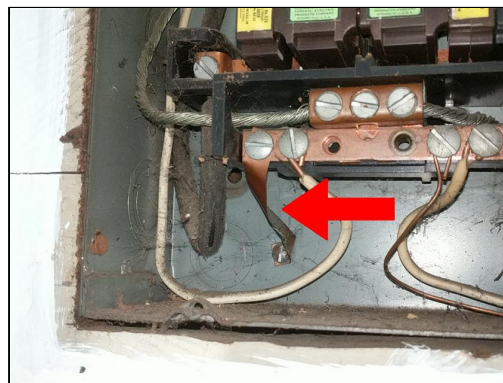
10.2 (5) The neutral and ground appeared to be bonded at the sub-panel. This is an unsafe condition which creates multiple neutral return current paths, including through the ground wire. The neutral and ground should only be bonded at the main distribution panel. Recommend further evaluation and correction by a qualified electrician.

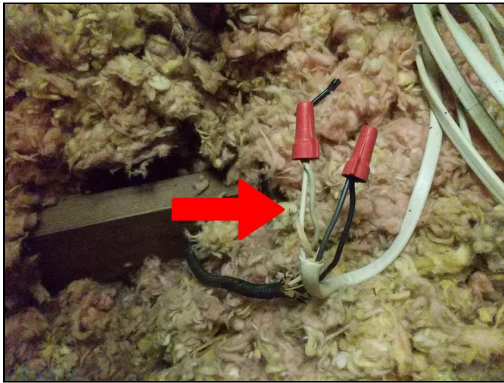
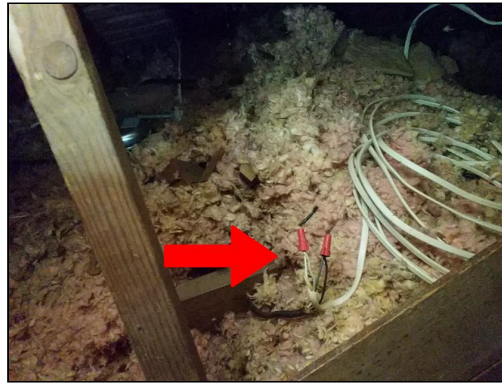
10.4 (1) Exposed wire splices were visible in the attic. This is a fire/ electrical shock/ electrocution hazard. All wire splices should be enclosed within an approved junction box with an approved, listed cover. Recommend correction by a qualified electrician.

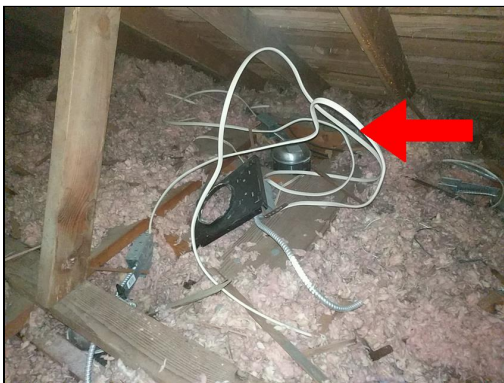
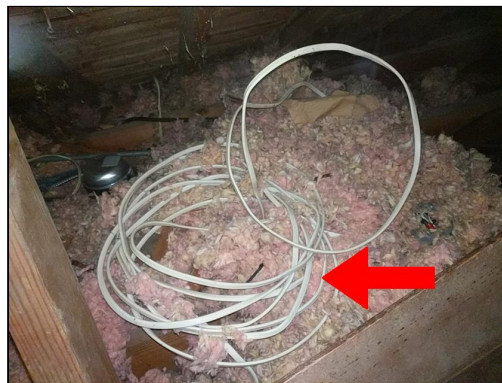
10.4 (2) Poorly supported wires were visible in the attic and need to be properly fastened to the framing. Safe building practices require wiring to be supported at intervals no greater than 4 feet-6 inches. Recommend further evaluation and correction as needed by a qualified electrical contractor.

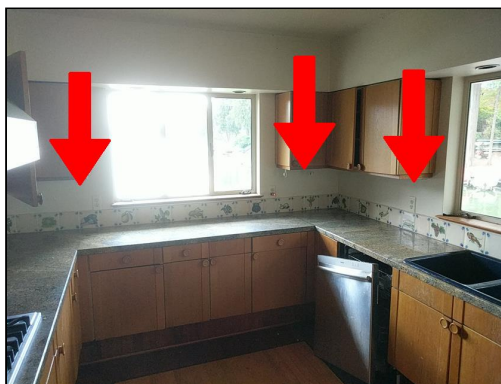
10.5 One or more electrical receptacles in the kitchen had an open ground. Other receptacles in the home were grounded, which indicates a potential wiring deficiency at the ungrounded receptacle(s). Recommend further evaluation and correction by a qualified electrical contractor.

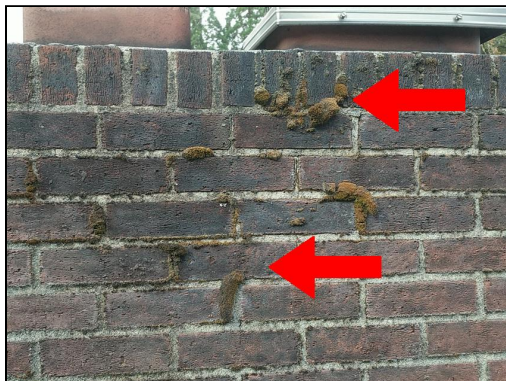
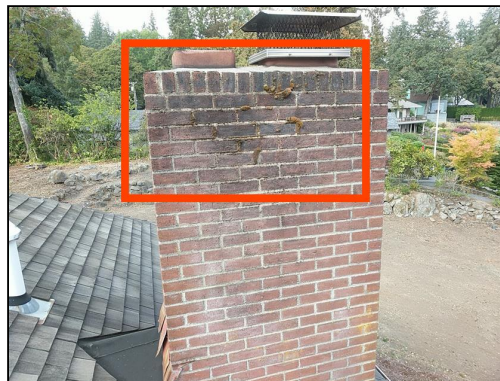
12.0 Chimney mortar joints had deterioration resulting from long term moss growth. Recommend further evaluation by a qualified mason or chimney contractor for options and costs for repairs.

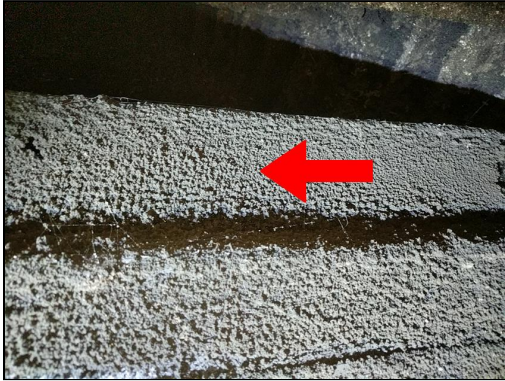
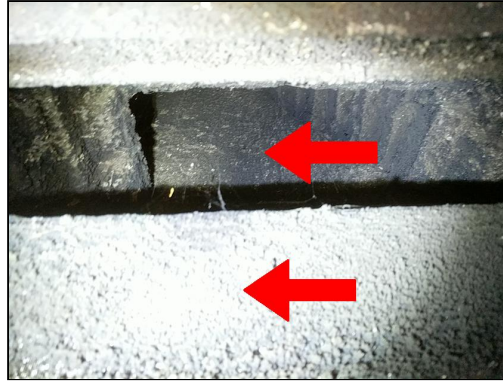
12.1 Severe levels of creosote buildup were visible in the chimney. Creosote is a by-product of burning solid fuel materials and is flammable. Creosote buildup in the chimney is considered a fire hazard.

Recommend a full cleaning and evaluation of the fireplace system by a qualified fireplace professional prior to use.

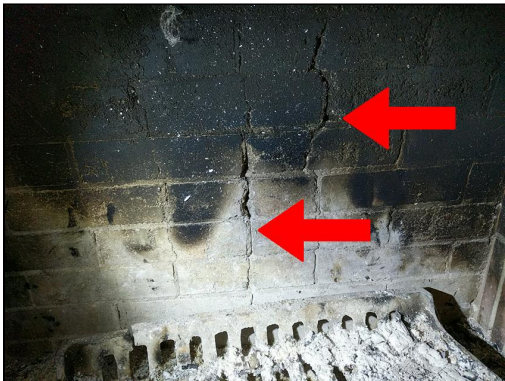
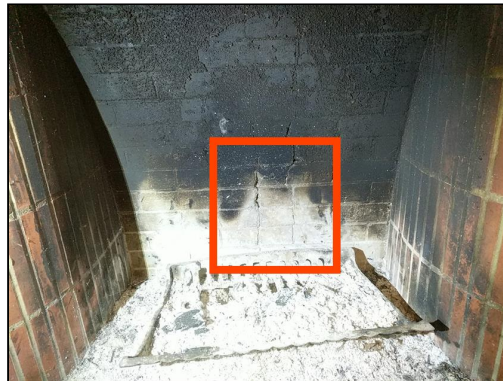
12.2 The fireplace had deteriorated mortar joints and are a potential fire hazard. Recommend further evaluation by a qualified mason or fireplace contractor prior to use to confirm fireplace is safe for use, or to perform repairs as needed.

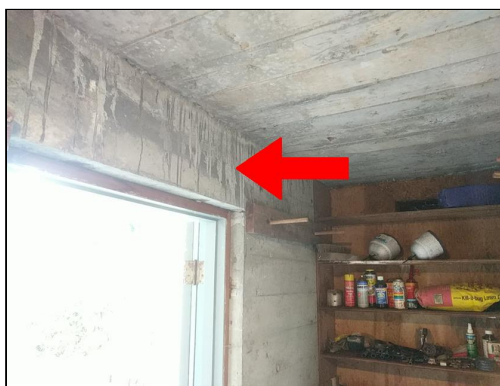
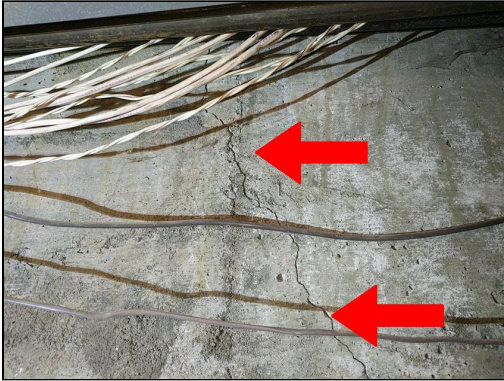
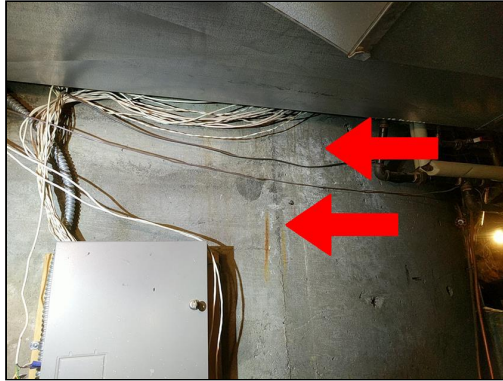
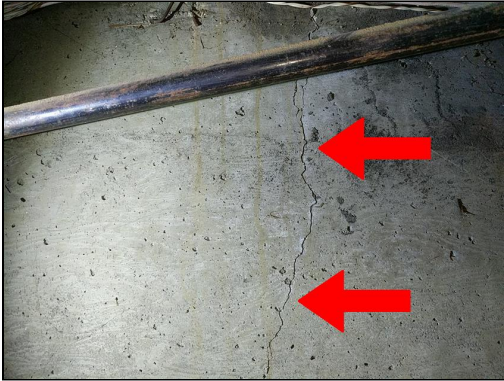
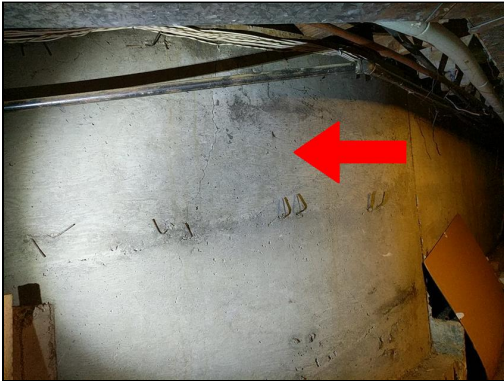
13.1 Cracks of varying width were visible at multiple areas in the foundation walls which appeared to be the result of settling and soil movement. Recommend further review and/ or repairs by a qualified structural engineer.

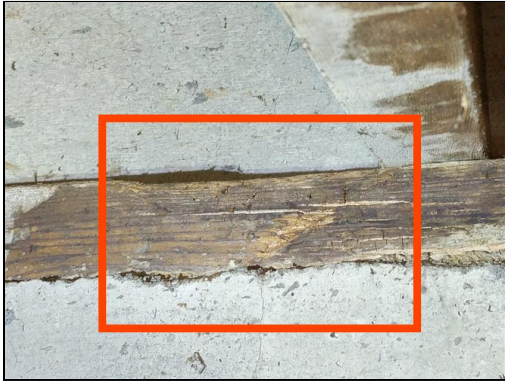
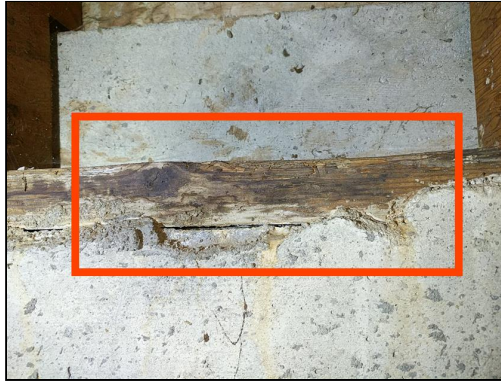
13.3 (1) The sill plate had wood rot visible at multiple areas towards the north side of the home. This may be the result of a negative grade in the slope at this area (see notes at item 1.1) which is allowing excessive moisture contact with the home. Recommend further evaluation and repairs as needed by a qualified contractor.

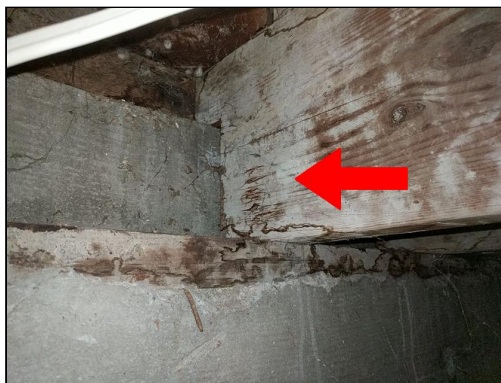
13.3 (2) Water staining was visible at multiple floor joist ends at the east and north sides of the home. This may be the result of a negative grade in the slope at this area (see notes at item 1.1) which is allowing excessive moisture contact with the home. Recommend further evaluation and repairs as needed by a qualified contractor.

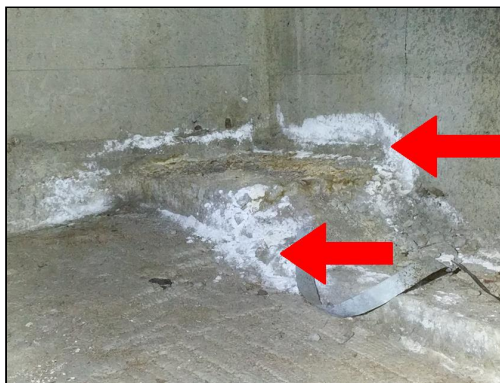
13.8 (1) Efflorescence deposits were visible at multiple interior surfaces of the foundation walls in the crawlspace. Efflorescence is a white, powdery residue left by moisture wicking through the foundation wall and its presence indicates high moisture levels in soil near the foundation. Excessively high moisture levels in soil supporting the foundation can cause various structural problems related to soil movement. Improvements to the grading and drainage around the exterior of the home will likely help improve conditions related to moisture against the foundation walls. Small amounts of efflorescence is not a cause for concern but should be monitored; if this condition appears to worsen over time, steps should be taken to improve grading and drainage.

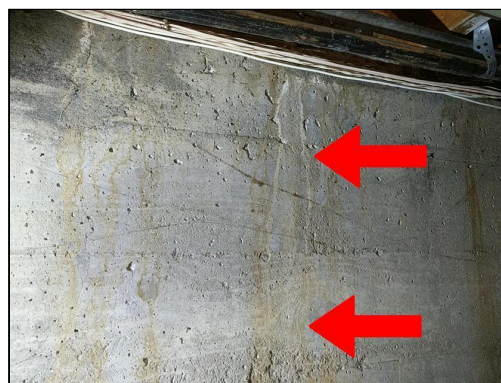
13.8 (2) Mud stains on the foundation walls at multiple areas indicated that water intrusion has occurred at these areas in the past. This is likely due to insufficient grading around the home's exterior. Corrections to the grading will greatly reduce the likelihood of this happening in the future. Recommend monitoring during the rainy season; if water entry appears to be a consistent problem steps should be taken to correct grading and drainage around the home. See item 1.1 for additional notes.

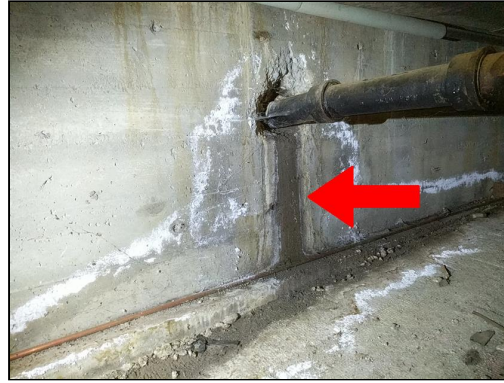
13.8 (3) Active moisture intrusion was occurring through the foundation wall around the main waste line. I could not determine if this is surface water or waste water due to a broken or damaged waste line. Recommend a sewer scope be performed by a qualified contractor to further evaluate possible causes of moisture intrusion at this area.
